The second TSR.2 XR220 arrives at Boscombe Down and causes some headaches

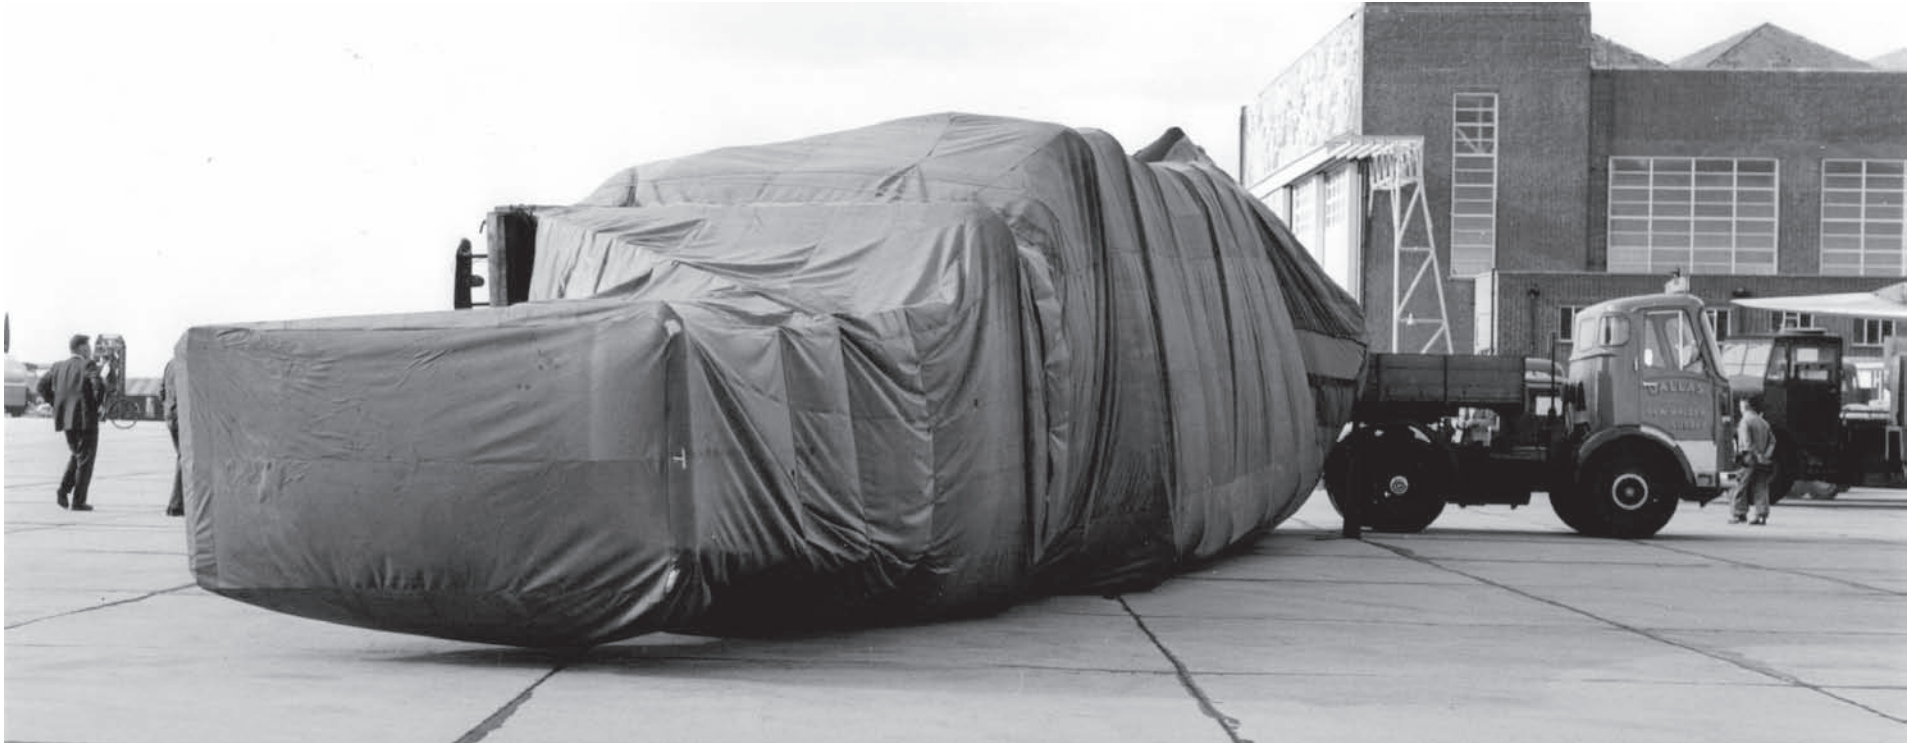
So, when the second TSR.2, XR220, arrived at Boscombe it famously fell off the back of the lorry, and is seen here in the keeled over state.

The resultant damage was not severe, but nonetheless assessment and repair took some considerable time: had the incident not occurred, the aircraft would undoubtedly have flown long before the date on which the cancellation was announced.

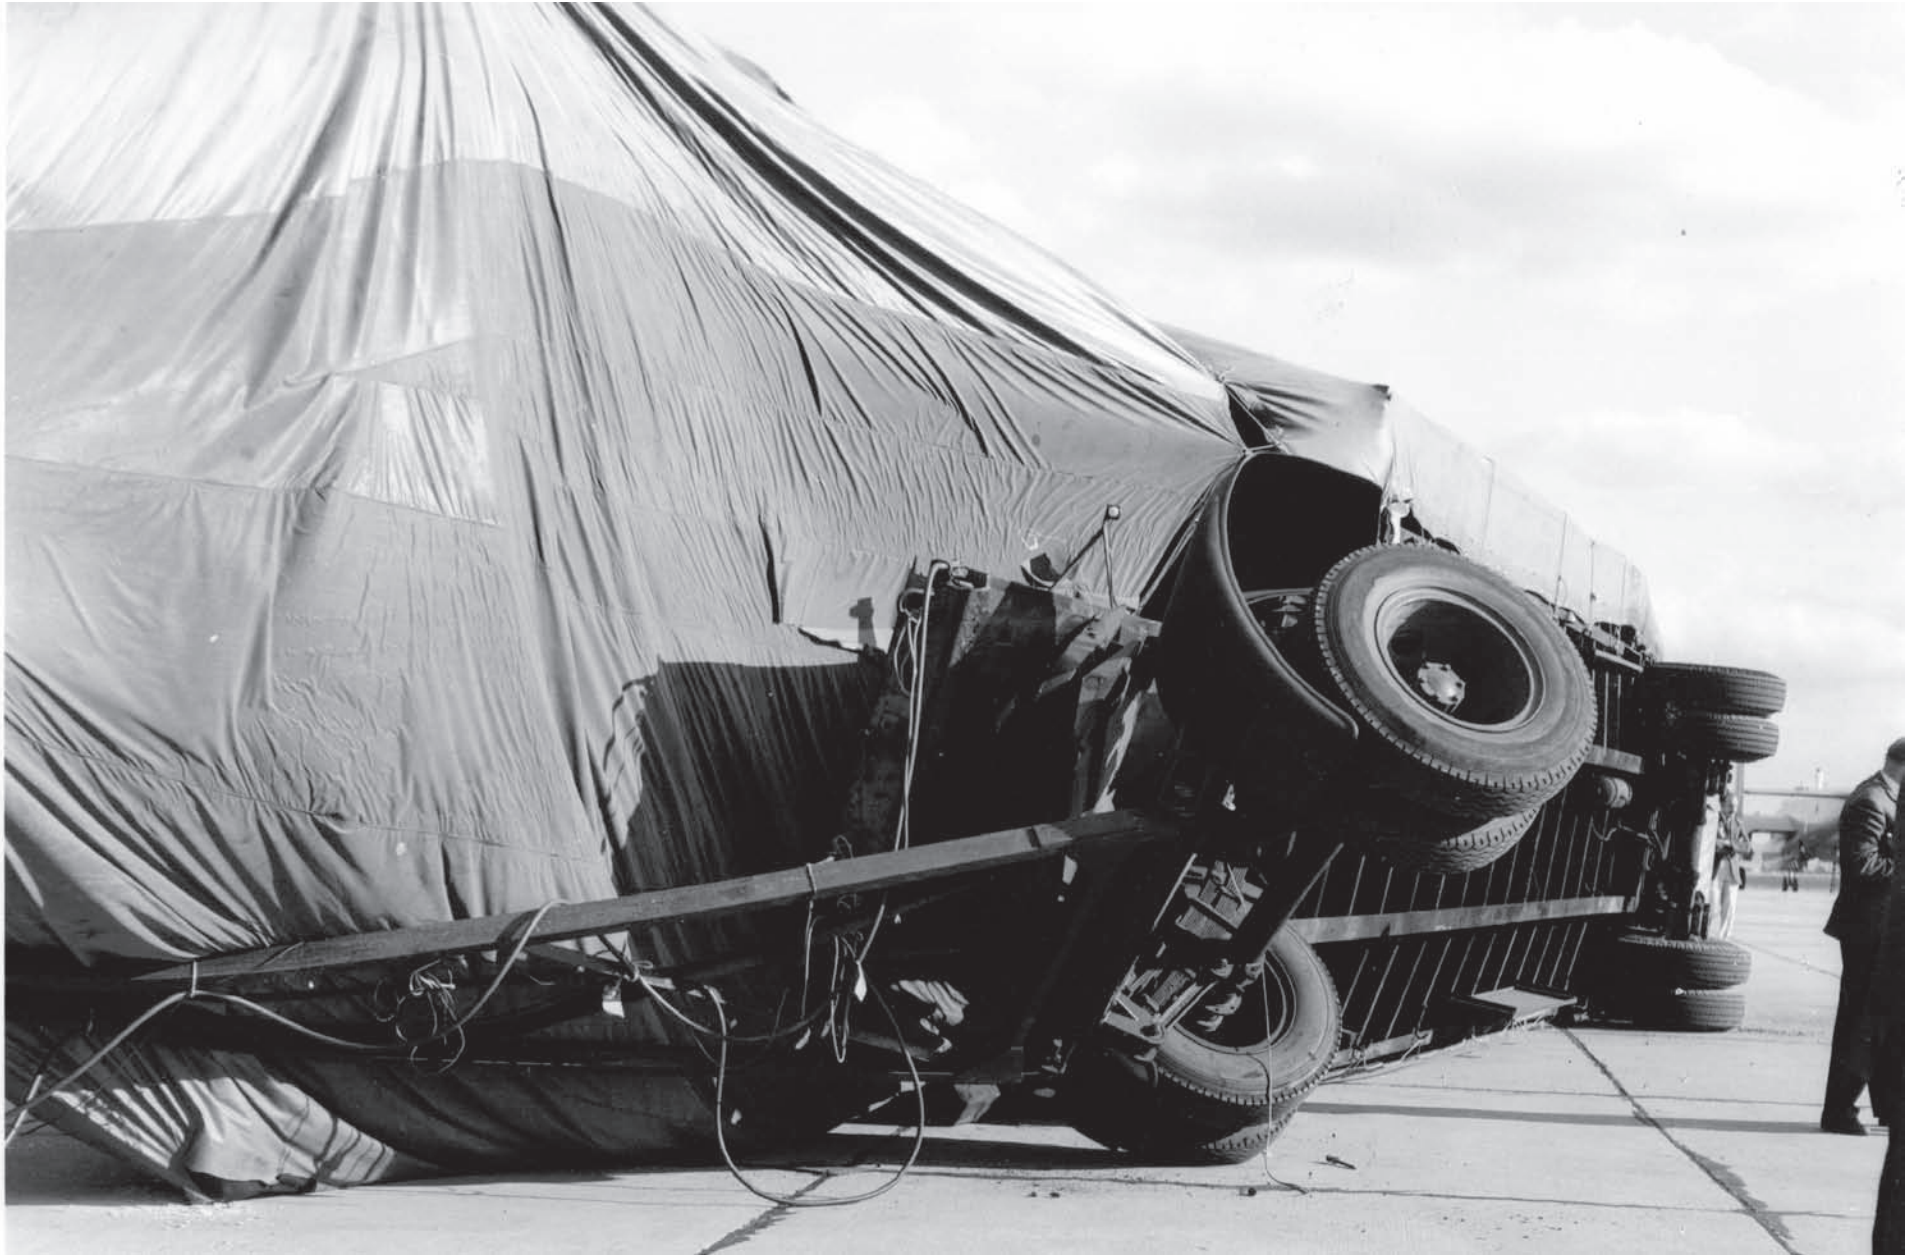
Next morning, the military turned up and also the air force to see how it could be righted in case it ever happened in service and they would know what to do. We removed the covers to see what damage we could see

and found that the iron work used for lifting had broken out of its place on the trailer and had punctured the aircraft skin in several places.

The stress people now took over to discuss the best way to separate '220 from the trailer without causing any undue stresses. The time it took wasn't surprising, I think one of the main concerns was the fact that the main elevon shaft on the port side was taking the weight of aircraft and trailer. Well it was decided to lift 220 and trailer together and then separate while they were supported on cranes. This involved, if I remember correctly, six cranes and it wasn't easy as the iron work was heavy and of course it was at an awkward angle. However it was done and the two bits were separated and we were left with a hanging fuselage albeit at 90deg to normal.

Well here we are with one fuselage hanging on cranes 90deg from its normal position and how to turn it. The first thing we did was to get a steel girder that could be bolted to the wing pick up points that had a central shackle that we could hook on to yet another crane, this crane then took most of the load.

The next job was to get the starboard main undercarriage out but it first meant getting the doors open to get in to connect a hand pumped hydraulic rig, not easy considering the angle of the fuselage but it was done and we started to pump out the undercarriage, It was a bit tricky because the crane that was attached to

the wing pick up points had to be raised as the undercarriage moved further out and turned the fuselage. The undercarriage was eventually pumped right out and into lock, the weight of this was sufficient to bring the aircraft more or less into normal position and it was lowered until it was touching the ground so now we had 220 on its starboard undercarriage, hanging on the central crane with a crane at the nose and one at the tail to keep it level.

The port main undercarriage was then lowered and locked down and then the nosewheel was fitted, the cranes were removed and there she stood on her own - albeit with a few holes in the skin. It was only the heavy weight of the undercarriage that made the fuselage turn. Without it I don't know how we would have done it, so now all we had to do was to tow it into the hangar and it didn't seem to be much the worse for wear. And that's it and that is where the fortnight in time went!!
