Dancing on foam

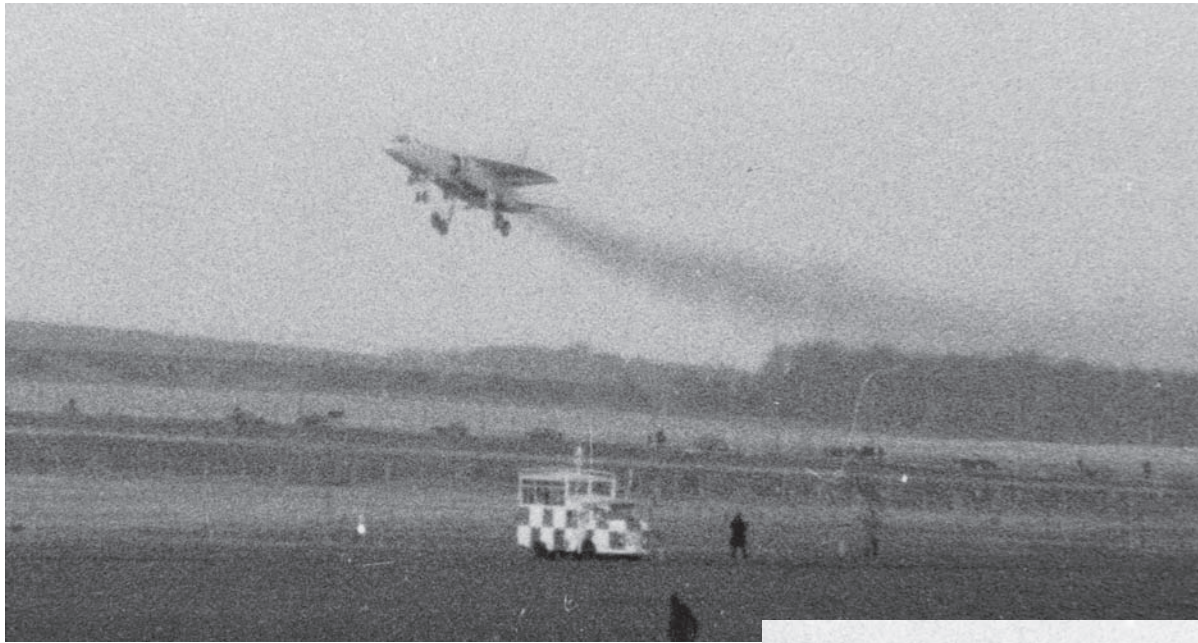
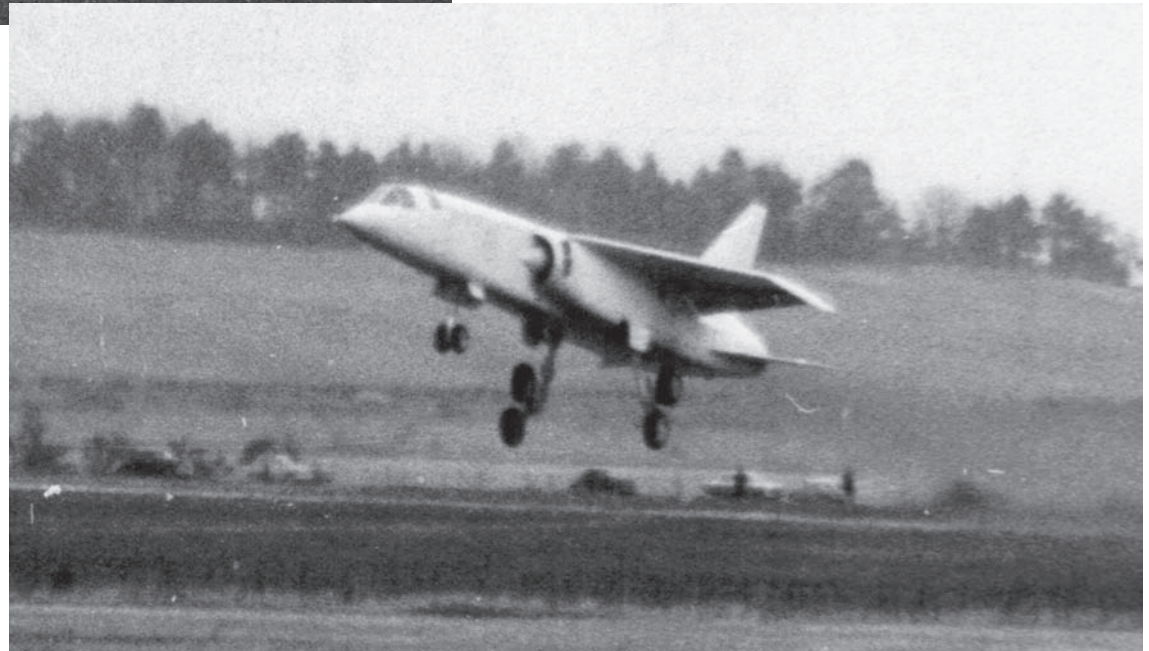
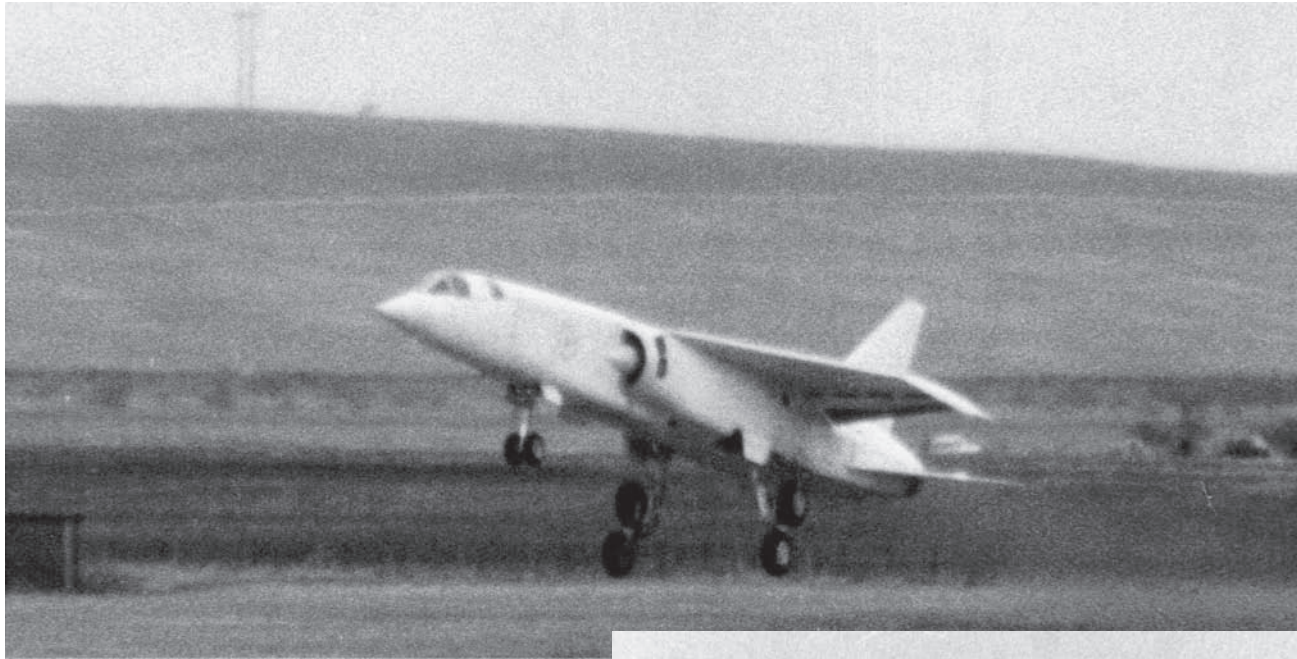
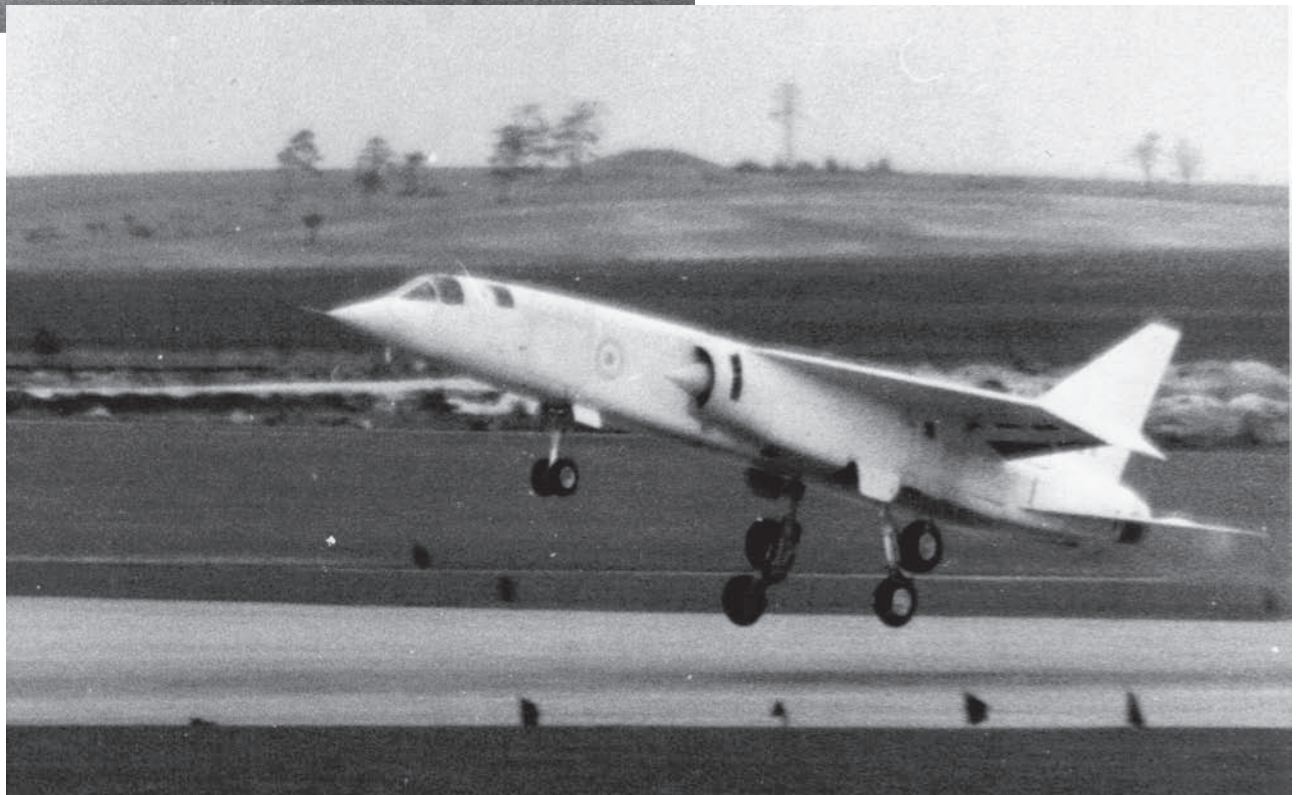
Thus XR219 landed on a carpet of foam laid along Boscombe Down's main runway, to see if this would dampen the shaking - it was so severe that it was blurring the pilot's vision for a short time.

This series of photos, taken on a very long-focus lens, are dated 21 January 1965, which would make this Flight 6.

Early in the flight trials it was noticed, indeed it was dramatic, that there was a pronounced lateral oscillation of the cockpit on landing, and tests were carried out to try and identify the cause and mitigate the effect.

In the end it was the basic design of the main undercarriage that was thought to be the cause, and an interim solution was tested when the aircraft was at Warton. When the project was cancelled on 6 April 1965 XR219 was on lay-up for a series of modifications, including the hoped-for permanent solution, but this was never flown.
